Thesis for the Degree of Master of Science in Environmental Science  
and Management

**Assessing the Status and Effectiveness of dykes in Lower Karnali  
River Basin, Rajapur Municipality, Bardiya, Nepal**

**Pokhara University, Nepal**

**December 2023**

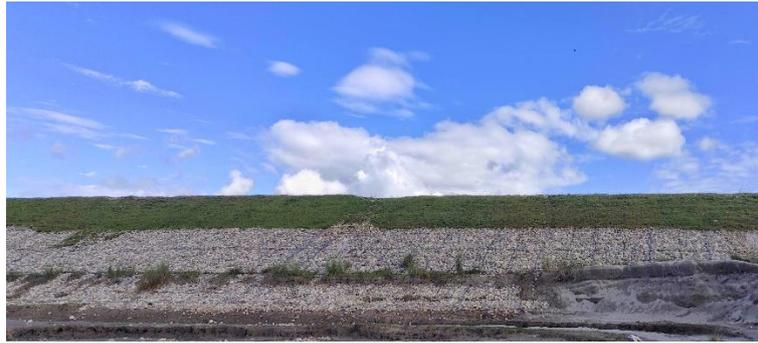
The stones of the river packed in the gabion mattress protect the slope of the dykes. These stones are round as well as angular which helps in slope protection.

Figure 8: Riverside slope of the dyke

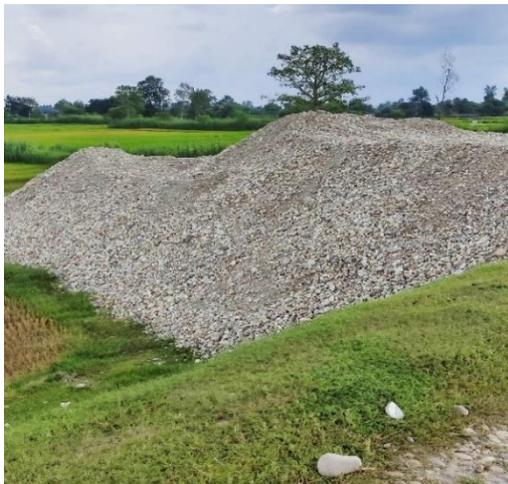
There is a provision of pre as well as post flood inspection of dykes in lower Karnali river basin. Maintenance materials are also kept ready for the time of emergency. The top width of the dyke and the availability of turning platforms at every 1km helps for vehicular movement at the time of maintenance. Areas where dykes are destroyed or damaged are now maintained using big boulders on the slope which are often cost effective as well as requires little to no regular maintenance. In our FGD with village chiefs, they reported that when the dykes breach, the communities often donate their labor for the maintenance of the dykes. Similarly, they are also involved in cleaning of sluices as well as Kulos such as Bhadali Kulo. There is also a provision of excavation of river materials of Karnali River through tender. The excavation provides additional income to the municipality, as well as removes sediments deposited on the river.

Figure 12: Materials for maintenance of dykes

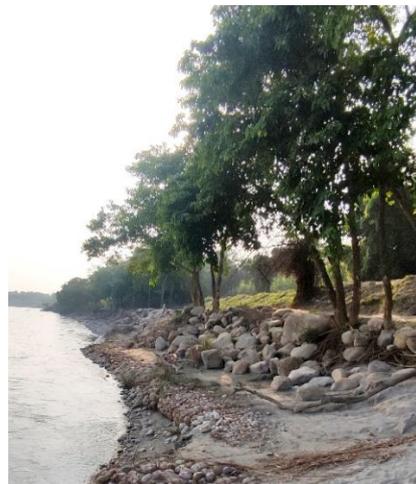
Figure 13: Boulders' dyke

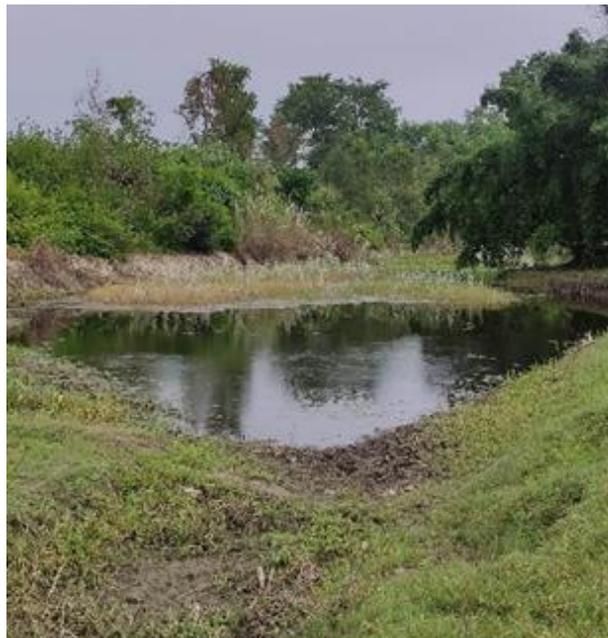
Seepage was also a problem, especially in Tighra (Ward 3) and Tihuni (Ward 1). Flood often gets stagnant in some areas behind dykes because of lack of passage/drainage from land to the river. The areas where seepage are a problem are shown in the figure below.

Figure 16: Stagnation of water behind dykes

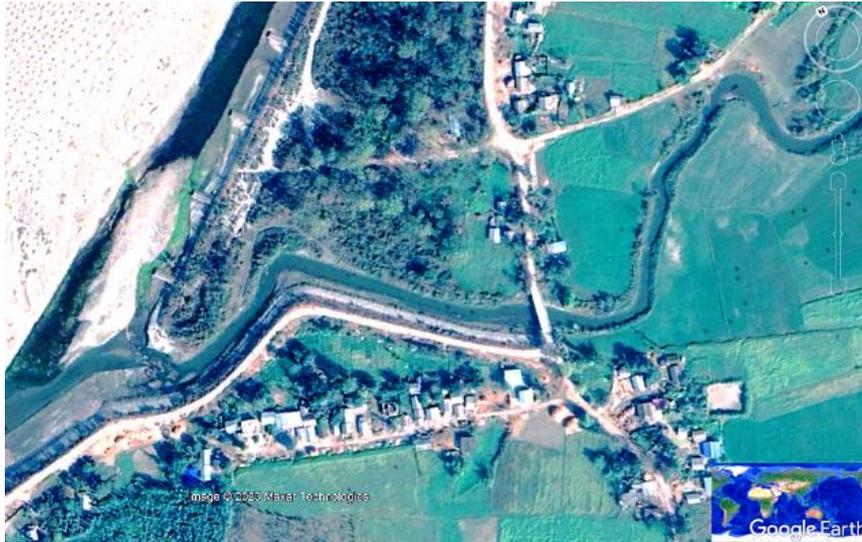
During monsoon when the water discharge in Karnali River increases, it causes the backflow of water of Bhadali Kulo back to agricultural land and even human settlement. 12% of the samples of Ward 1 said that this was one of the reasons of flood in Ward 1 of Rajapur Municipality.

Figure 26: Meeting point of Bhadali Kulo and Karnali River (Source: Google Earth Pro)

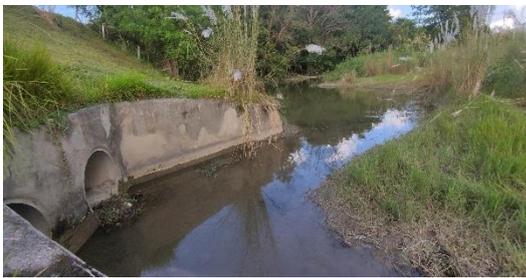
Water stagnation at AFS
